Hot Corrosion of Coated Superalloys in a Gas Turbine Environment

Final Report

15 December 1970

H. SOLAR
DIVISION OF INTERNATIONAL HARVESTER COMPANY
2200 PACIFIC HIGHWAY SAN DIEGO, CALIFORNIA 92112

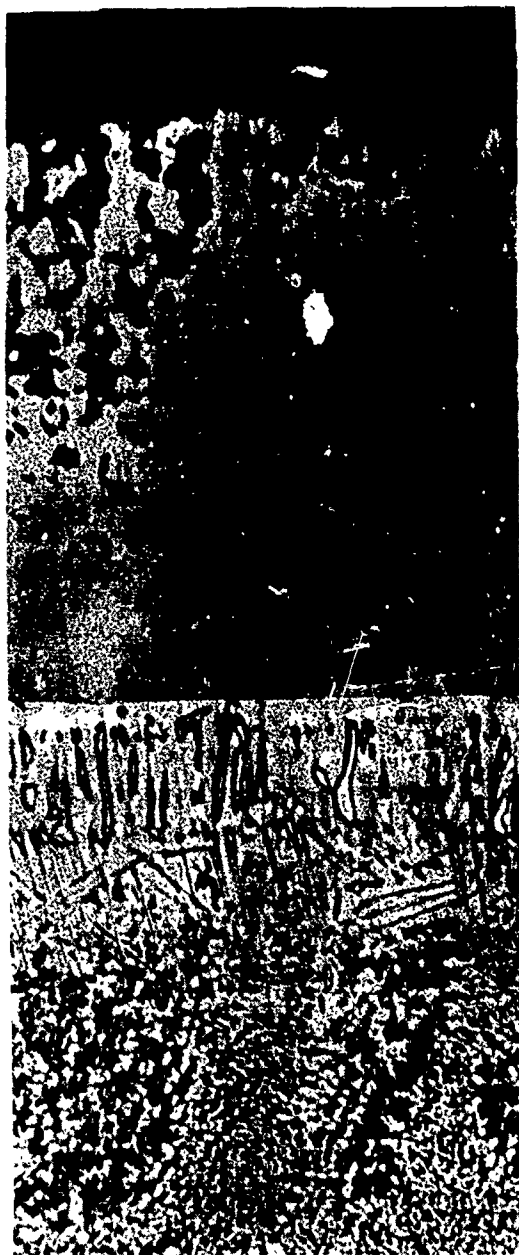
FIGURE 86. MICROSTRUCTURE OF COATING A ON U-700 ALLOY AFTER
HOT CORROSION TEST AT 1650°F FOR 150 HOURS

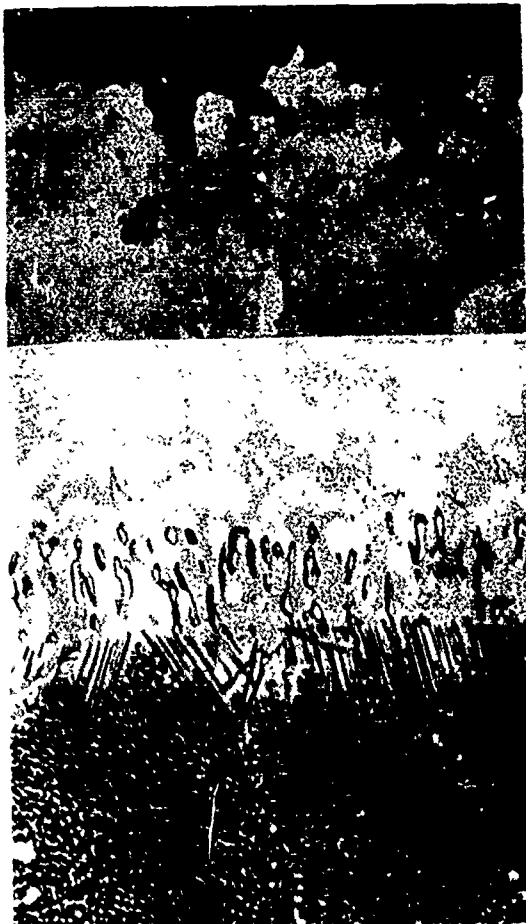
FIGURE 92. MICROSTRUCTURE OF COATING J ON U-700 ALLOY AFTER HOT CORROSION TEST AT 1650° F FOR 150 HOURS

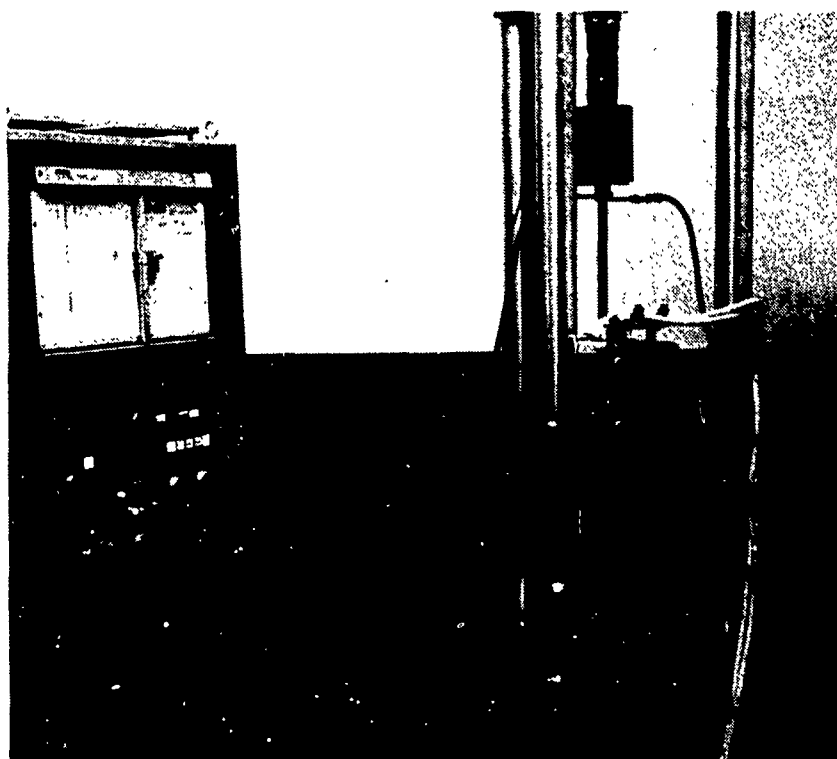
FIGURE 134. MECHANICAL FATIGUE TEST APPARATUS

- The stress for failure in 5,000 to 50,000 cycles was established at 1400°F in an oxidizing environment.
- Coated and uncoated specimens of each alloy were subjected to furnace exposure for 500 hours at the following temperatures:
 - Nickel-base alloys - 1800°F
 - Cobalt-base alloys - 2000°F
 - (Uncoated alloys were exposed in an inert environment and the coated alloys in air.)

- Following the furnace exposures, specimens were fatigue tested to failure at 1400°F.
- The test stresses were calculated based on original cross-sectional areas of the bars measured before coating, and also on the unaffected cross-sectional areas of the coated specimens after the high temperature exposures.
